# Reconditioning of Diamond Coated Tools and Its Impact on Cutting Performance for CFRP Laminates

**Abstract:** In recent years, CVD diamond-coated tungsten carbide (WC-Co) tools have been widely utilized due to their benefits in the machining of non-ferrous alloys and polymer composite materials, especially carbon-fiber-reinforced plastics (CFRPs). The reconditioning of such coated tools is economically attractive due to their high cost and short tool life. The decoating of the remaining diamond film from the used tools and the subsequent surface preparation by wet chemical pretreatment are essential steps for new CVD diamond film formation. Previously, it was shown that reactive ion beam etching (RIBE) could effectively remove CVD diamond films. However, some degree of WC-Co tool substrate damage is expected due to the high ion energy in RIBE and the chemical activity in wet etching. This study addresses the effects of RIBE decoating and surface pretreatment steps on WC-Co tools with a complex shape in terms of the ion-induced surface damage, geometry alteration, and adhesion of a subsequently re-applied CVD diamond film. Moreover, the cutting performance of the tools subjected

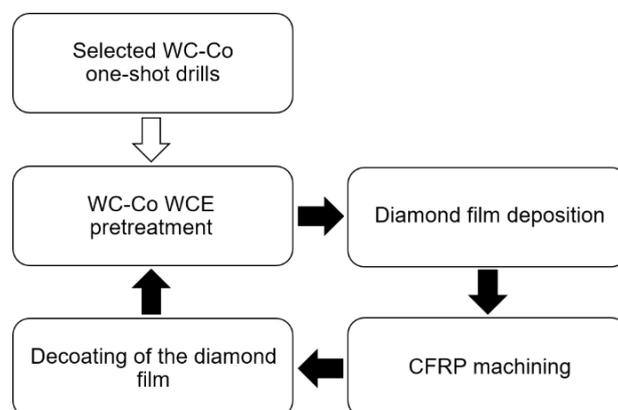
**Figure 1.** Tool life with multiple reconditioning cycles.

In this study, as shown in Figure 1, the substrate pretreatment (WCE), B-MCD deposition (CVD), CFRP cutting (CT), and film decoating (RIBE) were conducted repeatedly on one-shot cemented carbide drills in order to emulate the practically viable tool life cycle (TLC). The tool substrate and the film properties were investigated at each step using a combination of surface characterization techniques such as scanning electron microscopy (SEM), confocal scanning laser microscopy (CSLM), and Raman spectroscopy. Moreover, the cutting performance was evaluated during the CT through flank wear and CFRP hole quality assessment. The evaluation was performed for three consecutive TLCs, including the TLC0 (WCE0, CVD0, and CT0)—a newly deposited tool, the TLC1 (RIBE1, WCE1, CVD1, and CT1)—a first-time reconditioned tool, and the TLC2 (RIBE2, WCE2, CVD2, and CT2)—a second-time reconditioned tool.

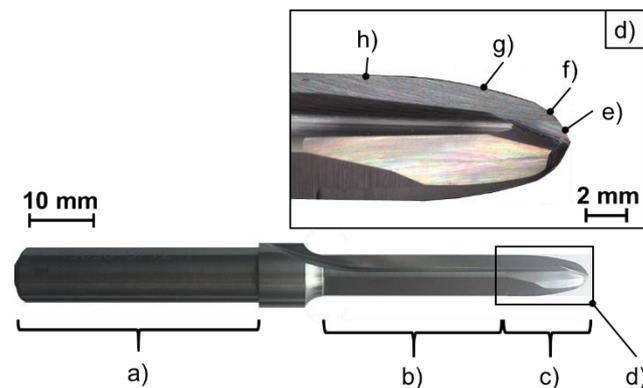
**Figure 2.** One-shot WC-Co drill utilized in the current study: (a) drill shank; (b) reamer cutting portion; (c) cutting edge portion; (d) magnified view of the drill cutting edge portion; (e) primary cutting edge; (f) rounded corner; (g) secondary cutting edge; (h) tertiary cutting edge.

One-shot WC-Co drills with a specific geometry optimized for CFRP materials were selected for the experiment. The structure of the drill bit is presented in Figure 2. The drill with a nominal diameter of 6.36 mm had two straight flutes with a tip point angle of  $120^\circ$  and two curve-shaped edges, namely, primary and secondary cutting edges, joined by a rounded corner. A straight tertiary cutting edge (Figure 2b) formed a reamer part of the tool, aimed at the smoothing of the drill holes and providing the hole diameter close to the nominal. Such an innovative drill geometry was described in a corresponding patent [16]. Other drill dimensions were as follows: the total length was 88 mm, the cutting edge length was 40 mm, and the shank diameter was 9 mm. All drill substrates were made of K01 graded tungsten carbide with cobalt (WC-6 wt. % Co). This material is commonly used to manufacture complicated-cutting-shape tools and can be coated with CVD diamonds. The total of three drill bits were investigated with the reconditioning steps.

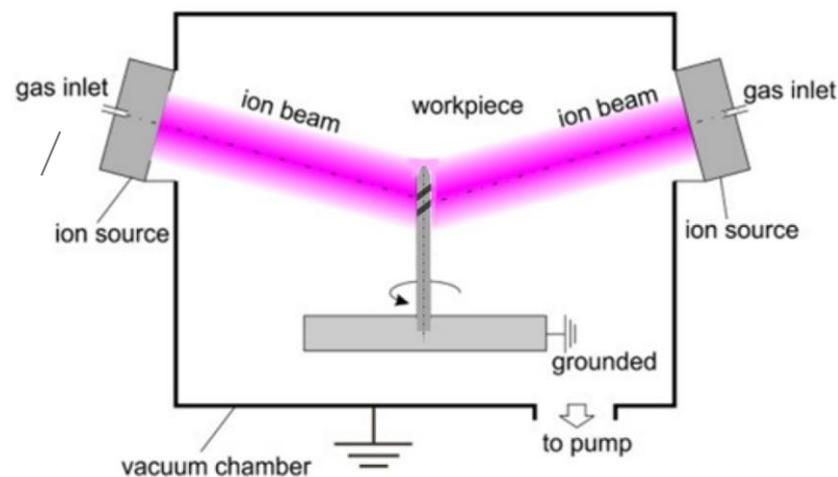
**Figure 3.** Reactive ion beam etching (RIBE) experimental setup [14].

Diamond-film RIBE decoating was performed with a commercial ion etching system (IE400, ShinMaywa Industries, Hyogo, Japan). The experimental setup is shown in Figure 3. The diamond etching was achieved through oxygen ion beams generated with CDIS. The CDIS beam generation relies on the crossed electric and magnetic field discharge, where electrons are trapped in a circular region near the magnetic trap while ions are freely accelerated by the electrical field. More details of the CDIS principle and structure can be found elsewhere [19].

The tools for decoating were placed in a vacuum chamber and exposed to a CDIS concentric array. The beam size of CDIS was  $\sim 100$  mm in diameter and covered the whole coated length of the processed tools, so that the whole coating was etched with a good uniformity along the vertical axis. In addition, the tools were rotated planetary in order to provide an even ion/radical flux exposure in the horizontal plane, which was previously shown to result in a good etching uniformity inside the flutes [20].

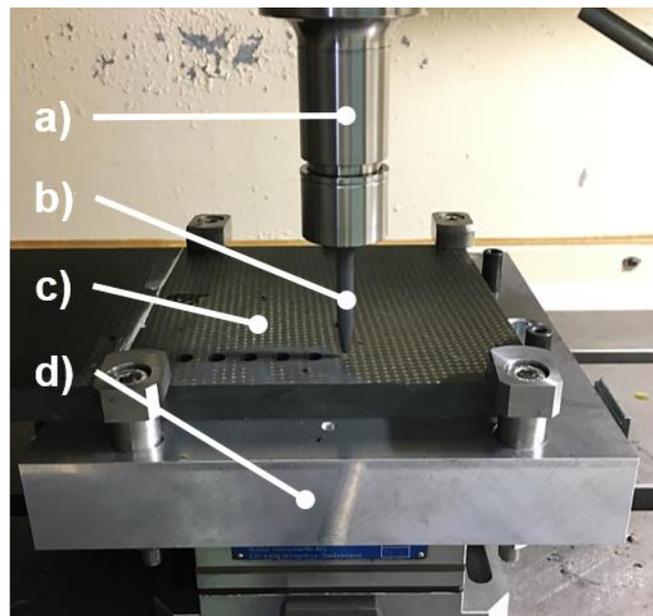
**Figure 4.** Experimental setup for cutting tests ((a), machine; (b), tested drill; (c), carbon-fiber-reinforced plastics (CFRPs) workpiece; (d), fixture).

A vertical milling center OKUMA MD-45VA was utilized to perform the drilling tests. The experimental setup is shown in Figure 4. The cutting parameters were as follows: the drill rotation  $n$  was 2700 rpm, the cutting speed  $V$  was 53.9 m/min, and the feed rate  $f$  was 0.1 mm/rev, which were kept constant. No coolant was applied during the tests. The number of drilled holes was limited to below 200 in order to avoid the drill substrate wear and the necessity of tool regrinding. A drill flank wear was measured after each 20 holes using a digital microscope (VHX-1000SP, Keyence, Osaka, Japan). After drilling 200 holes, the drills were checked for the damage to cutting edges, such as cutting edge chipping or a fracture via SEM.

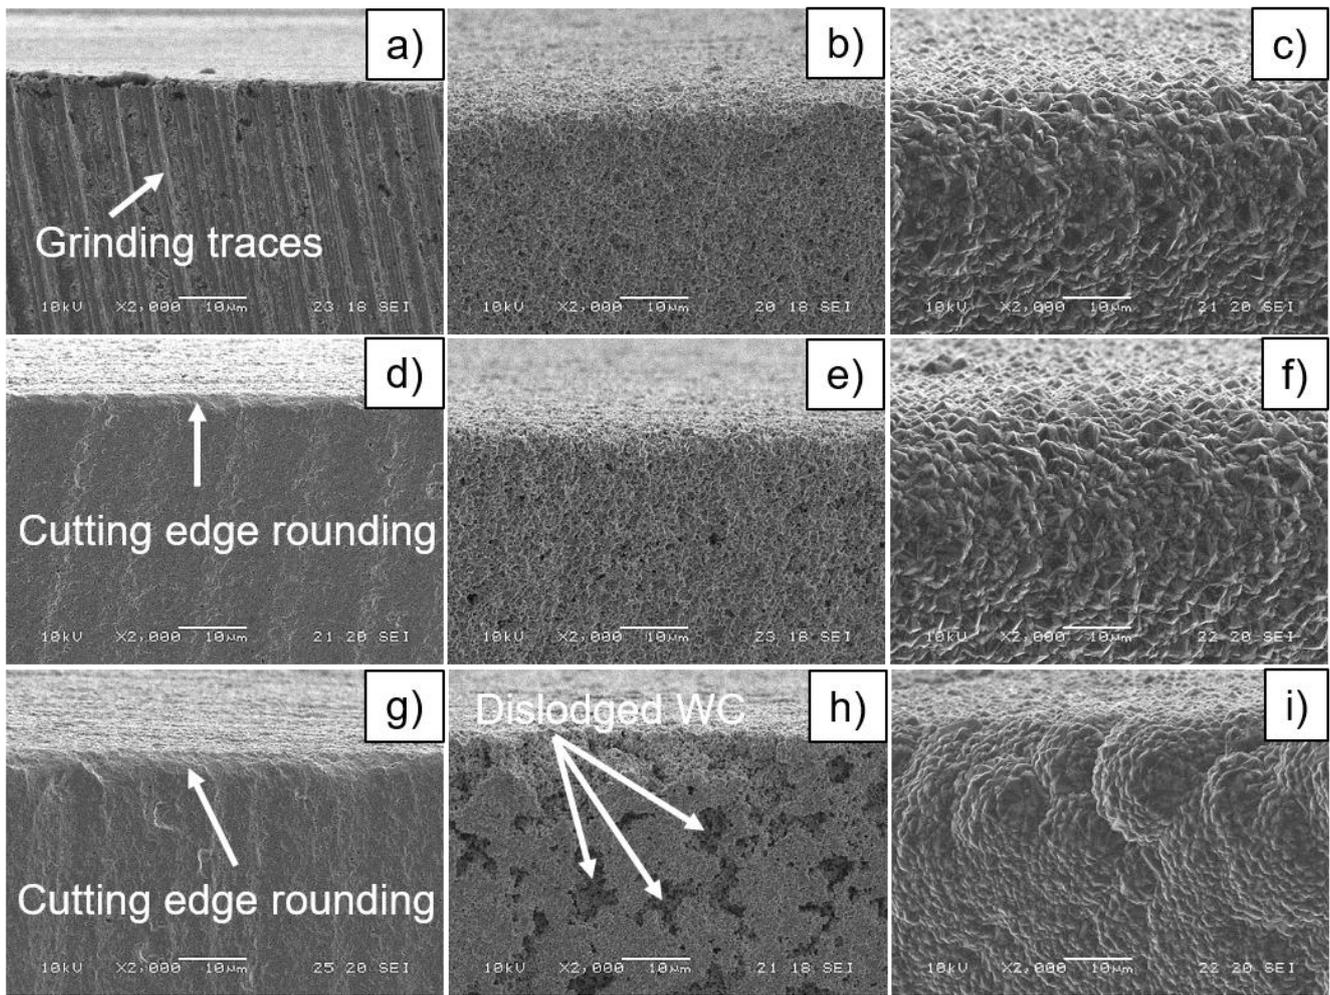
**Figure 5.** Morphologies of the drill flank surface, observed at 6 mm from the drill tip: (a) original, as grinded; (b) wet-chemical etching 0 (WCE0) of the new drill (TLC0); (c) chemical vapor deposition 0 (CVD0) of the TLC0; (d) reactive ion beam etching 1 (RIBE1) of the 1st-time reconditioned drill (TLC1); (e) WCE1 of the TLC1; (f) CVD1 of the TLC1; (g) RIBE2 of the 2nd-time reconditioned drill (TLC2); (h) WCE2 of the TLC2; (i) CVD2 of the TLC2.

Figure 5 displays the substrate surface morphologies obtained by SEM for different stages of the experiment, while Figure 6 shows the resulting surface roughness data of the stages. Surface texture parameter  $S_a$ , as an arithmetical mean height, based on ISO 25178—“Surface Texture”, was recorded and averaged from multi-point measurements on the flank surfaces of the drills. The scan size was determined by the optical magnification of the system (100×) in a resulting surface area of 129  $\mu\text{m}$  × 129  $\mu\text{m}$  with a profile Gaussian filter  $\lambda_c$  of 8  $\mu\text{m}$ .

The original drill substrate, as shown in Figure 5a, represented the as-ground surface depicting the directional marks left by the grinding process on the surface of the tool, which also provided a non-uniform texture in terms of the distribution of the WC grains and the Co binder due to the amount of surface damage after the grinding process [21]. These feed marks display an average surface texture roughness of  $S_a = 0.096 \mu\text{m}$ .

The surface morphology after the WCE0 process, as shown in Figure 5b, revealed a uniform surface with  $S_a$  value of  $0.151 \mu\text{m}$  and some directional surface features. The increase in the roughness after the process is attributed to the WCE, which attacked the WC grains and oxidized the cobalt binder to soluble Co compounds removed during the procedure under applied ultra-sonication [15]. Such a washing action may dislodge weakly bonded WC grains from the surface and create some porous surface textures. Further, Figure 5e shows a uniform surface with a roughness  $S_a$  parameter of  $0.153 \mu\text{m}$ , generated after the WCE1 process of the 1st reconditioning cycle. However, the surface, produced by the WCE2 process of the 2nd reconditioning cycle, had a rougher texture with  $S_a$  of  $0.160 \mu\text{m}$  and pitted areas, as shown in Figure 5h. It is possible to propose that an accumulative effect of removing the binder phase in WCE stages led to the formation of randomly distributed, Co-free areas of the substrate with a depth deeper than the WC average grain size. Then, the weakly bonded carbide grains were dislodged by cavitation during an ultrasonic washing action after the chemical etching. As a result, the non-uniform-sized pitted areas appeared on the substrate surfaces after the WCE2 process. Thus, three repeated chemical etching processes over-treated the surface and provided porous textures due to the loss of WC grains and the Co depletion.

On the other hand, the RIBE process generated a rather smooth and uniform surface after all decoating cycles. Figure 5d,g shows the morphologies of ion-etched surfaces after the 1st and 2nd decoating processes of the tool reconditioning, respectively. The roughness values of the etched surfaces consisted of  $S_a$  of  $0.085 \mu\text{m}$  and  $0.087 \mu\text{m}$  after the 1st (RIBE1) and 2nd (RIBE2) decoatings, respectively. The observed effect of the partial surface integrity regeneration via RIBE can be attributed to the physical sputter etching of the damaged the WC-Co layer by energetic oxygen ions down to the pristine WC-Co.

The surface morphologies of the deposited diamond coatings are shown in Figure 5. The diamond surfaces, displayed in Figure 5c,f corresponding to the TLC0 and the TLC1, respectively, showed similar continuous, well-defined faceted textures of randomly oriented diamond grains with an average size of approximately  $3 \mu\text{m}$ . Contrary, as shown in Figure 5i, the diamond coating deposited on the TLC2 consisted of a combination of small faceted grains in globular agglomerated textures distributed mainly along the cutting edges.

This difference between the observed diamond films may be attributed to a high diamond nucleation density as the result of the rougher surface due to a huge amount of pits at the surface, as shown in Figure 5h. As the depth of pits increased with the surface roughness, more diamond particles were embedded within the rough surfaces. This enhanced the nucleation of the diamond crystal and its growth behavior. Therefore, it can be proposed that the WCE2 process detrimentally reconstructed the surfaces, especially in the cutting edge areas, because over-treated surfaces induced the formation of non-uniform diamond films. A similar correlation between the substrate surface roughness and the diamond film morphology has been reported by Gomez et al. [17]. In their study, a diamond coating with a combination of small crystal facets in ball-like agglomerates was obtained on rougher samples compared between all pretreated samples.

The voids originated from the WCE2 step, as shown in Figure 5h. Evidently, the diamond growth started inside the voids but did not completely fill them out before the continuous film coalesced and encapsulated the voids, blocking the gas-phase C transport and deposition in those areas. The findings suggested that the WCE2 and further step conditions should be fine-tuned in order to prevent the formation of excessively large craters and subsequent film voids. Another possible way is to apply the selective seeding process that stimulates an in-depth diamond growth, as has been reported by Linnik et al. [25].

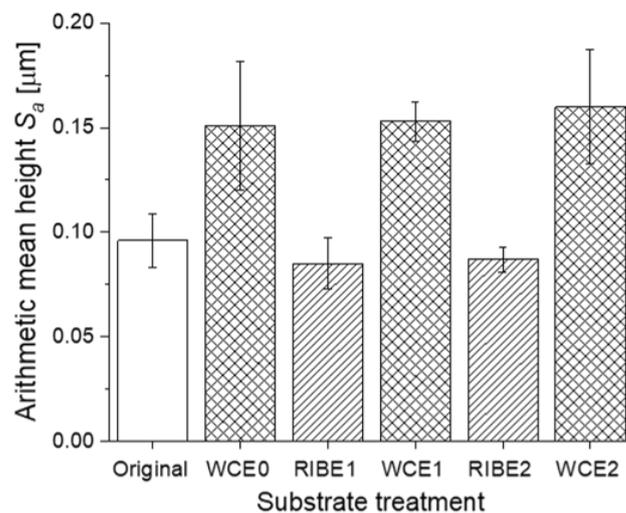
**Figure 6.** Substrate roughness characteristics by the arithmetical mean height ( $S_a$ ) of the surface texture.

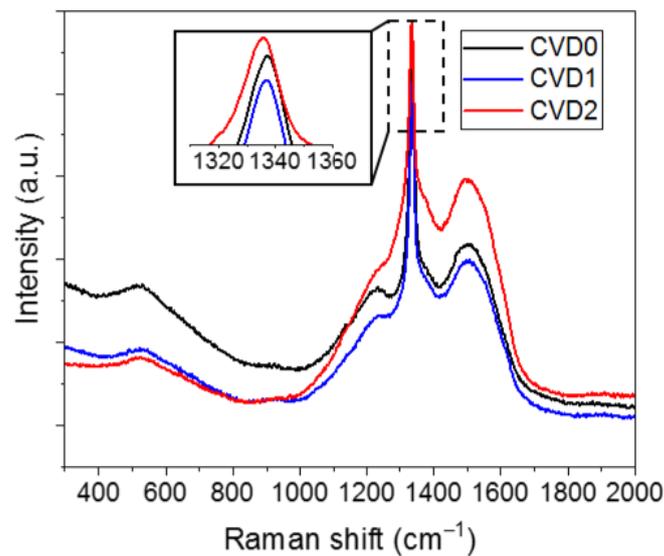
**Figure 7.** Raman spectra of the CVD0, CVD1, and CVD2 coatings, using a green ( $\lambda = 532$  nm) excitation.

In order to assess the quality of the deposited diamond coatings, Raman spectroscopy was employed. The Raman spectra of the diamond coatings are displayed in Figure 7, adopting the Raman microscope (RAMAN-11, Nanophoton, Osaka, Japan) and a laser with a visible excitation wavelength of  $532 \text{ nm}$ .

It was found that the peak around  $1332\text{ cm}^{-1}$ , indicative of the  $\text{sp}^3$  bonding of the diamond, can be visible evidently for all the films [22]. The Raman bands were present as  $1337.27\text{ cm}^{-1}$ ,  $1337.28\text{ cm}^{-1}$ , and  $1335.38\text{ cm}^{-1}$  in CVD0, CVD1, and CVD2 films deposited on the TLC0, the TLC1, and the TLC2, respectively. The wavelengths of these peaks shifted from the value of the natural diamond ( $1332.4\text{ cm}^{-1}$ ), indicating the residual stress in the diamond films.

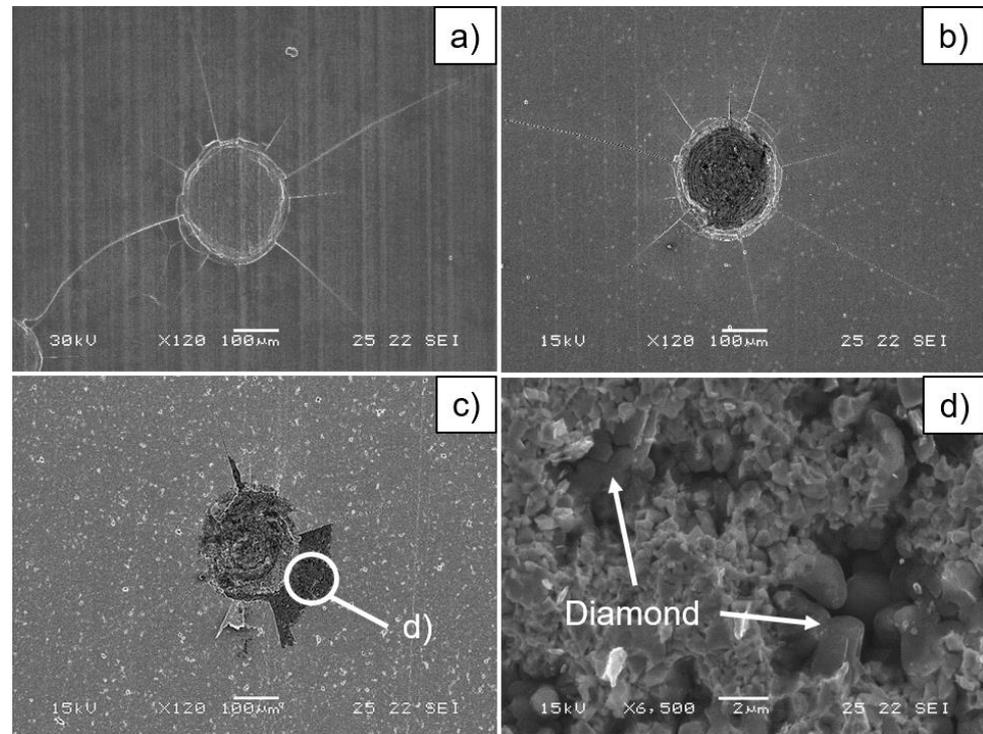
**Figure 8.** Scanning electron microscopy (SEM) images of indentation morphologies, obtained by a Rockwell testing machine with a load of 980.7 N on the TLC0 (a), the TLC1 (b), and the TLC2 (c,d).

In order to evaluate the adhesive strength between the deposited diamond coatings and the drill's substrate after the initial and reconditioning cycles, indentation tests were carried out using a Rockwell hardness testing machine with a diamond indenter, which had a conical angle of  $120^\circ$  and a radius of curvature at the tip  $0.2\text{ mm}$ . Each diamond-coated drill was tested under a load of  $980.7\text{ N}$ . Figure 8 shows the SEM images of the surface morphologies of the coated drills after the indentation tests. For the TLC0 and the TLC1, as shown in Figure 8a,b, respectively, cracks of the diamond coatings around the indenter trace were observed. On the other hand, Figure 8c reveals the peeling of the diamond film of the TLC2 after indentation. A magnified SEM image of the film-peeled area, presented in Figure 8d, showed the substrate voids partially filled with the diamond material. The

existence of the voids decreased the mechanical strength of the interface and created stress concentration regions. Thus, the adhesion force was significantly reduced.

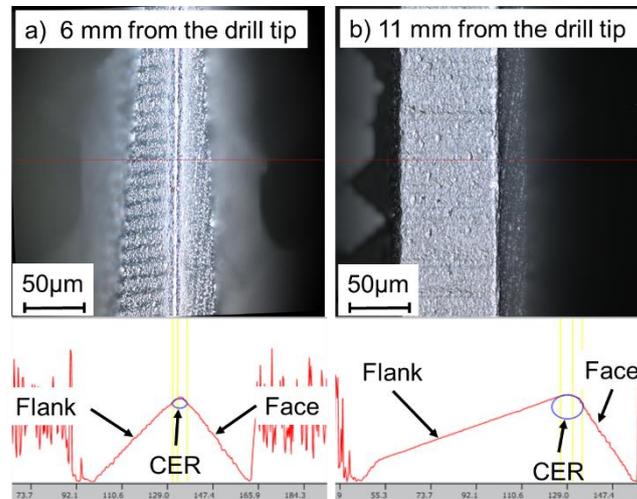
Figure 9. Measurement results of the cutting edge rounding (CER).

The first measurement position was determinate on the secondary cutting edge at 6 mm from the drill tip, and the drill cutting edge profile was characterized. It should be noted that the same position was used for the flank wear evaluation, described in the following section. The second measurement position, associated with the reamer geometry, was on the tertiary cutting edge at 11 mm from the tip. Figure 9 shows the cutting edge profiles for both measurement positions described above carried out by a laser microscope (OLS4100, Olympus, Tokyo, Japan). First, the three-dimensional (3D) images of the cutting edge in the measurement positions were obtained from a surface area of  $129 \mu\text{m} \times 129 \mu\text{m}$

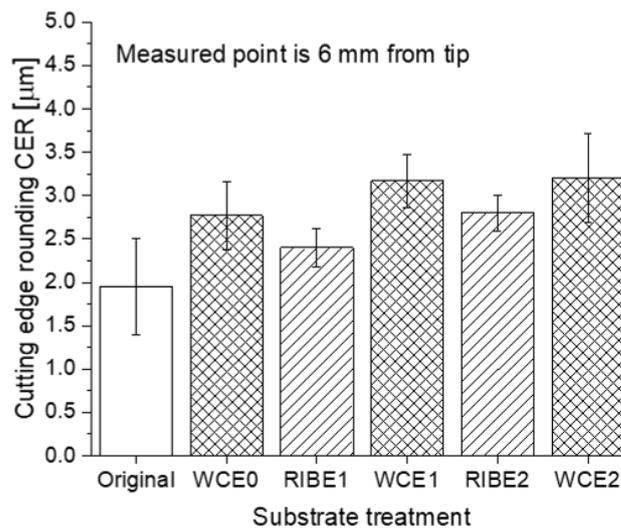
Figure 10. Change of the CER (6 mm measured point).

Figures 10 and 11 reveal the evolution of the CER values measured after the substrate treatment procedures. As shown in Figure 10, each pretreatment before diamond deposition led to increasing CER values. Because the chemical etching process accompanied the Co binder’s removal and loss of tungsten carbide grains, influencing the tool size and shape. On the contrary, the cutting edge sharpening effect was observed after the decoating stages. Although the film removal was not released uniformly for a complicated shape of the drill and the sputtering of the substrate occurred as well, the CER values decreased by approximately 0.5 μm every time for both the cutting edge geometries. The observed effect of micro-sharpening has been previously reported for medical needles exposed to ion beam irradiation with similar process parameters in the present study [30]. The mechanism consists in the incident angle-dependent sputtering yield, which drives the shape modification towards sharper edges in certain angle ranges and ion energies. For the cutting tools, the ion-induced sharpening of the edges may be beneficial from the standpoint of the cutting force reduction.

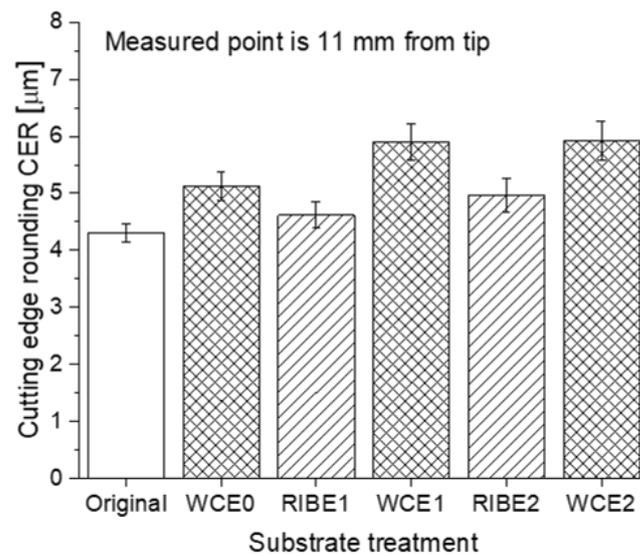
Figure 11. Change of the CER (11 mm measured point).

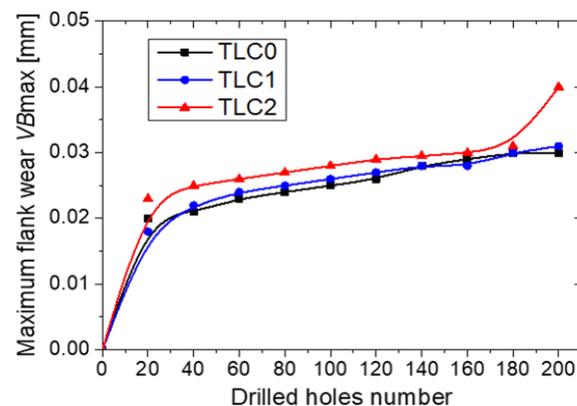
Figure 12. Variations of the maximum flank wear as a function of the drilled holes number.

In the cutting tests, tool wear was evaluated as the maximum flank wear land width ( $VB_{max}$ ) as a function of the drilled hole number, as shown in Figure 12. Based on trial cutting test results, the  $VB_{max}$  was always determined on the secondary cutting edge at 6 mm from the drill tip, which was placed close to the rounded corner connecting the secondary and the tertiary edges. Since there was a gradient in the tool wear from the corner of the drill cutting edge to the center, the area of the second cutting edge indicated above kept higher values of the flank wear measured in preliminary cutting tests compared to other areas of the drill edges. The results, shown in Figure 12, indicated that the evolution of the  $VB_{max}$  values for the TLC0, the TLC1, and the TLC2 can be divided into two regions. The first region was the primary wear taking place, when ~40 holes were drilled. The second region was the region of steady-state wear observed between ~40 and 200 drilled holes. This was a normal operating region for the cutting tool. Some minor differences between the flank wear values were observed for the new and reconditioned diamond-coated drills. The abrasion of rough grains of the B-MCD film occurred with a fast increasing trend of the flank wear value, until 40 holes were drilled. Then, the smoothed diamond film led to the gradually increased wear, until 200 holes were drilled. However, the flank wear progress of the TLC2 showed a dramatically increasing trend after drilling 180 holes, which is typical for an accelerated wear region with the vanishing of the diamond film and the progressive substrate wear.

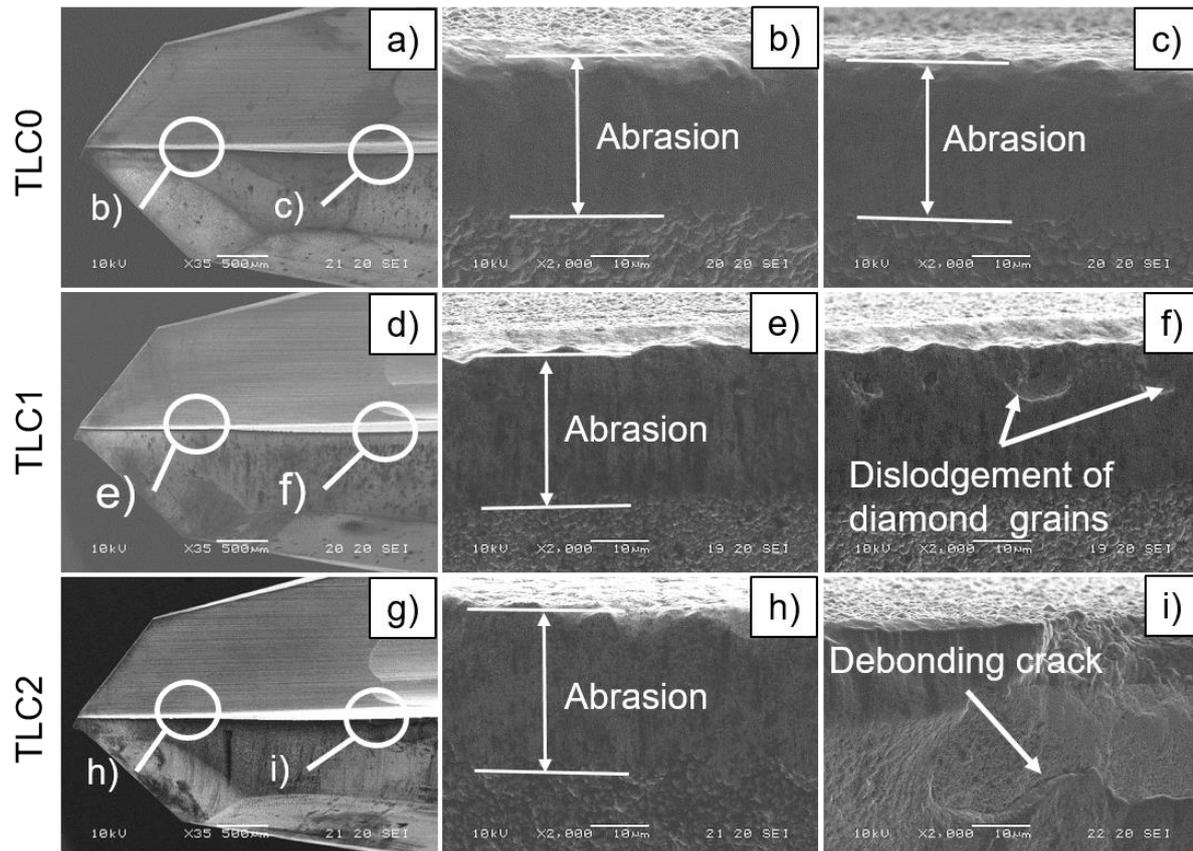
**Figure 13.** SEM images of the TLC0 (a–c), the TLC1 (d–f), and the TLC2 (g–i) after drilling 200 holes.

Figure 13 shows the wear morphologies of the tested drills after drilling 200 holes. For the TLC0, only the abrasion wear of the diamond film along the cutting edge was observed clearly, as shown in Figure 13b,c. The TLC1 images (Figure 13e,f) showed the worn diamond film with localized film flaked areas, while the film detachments and the worn areas of the substrate were observed for the TLC2, as shown in Figure 13i.

On the other hand, the drill tip areas of the TLC1 and the TLC2, as shown in Figure 13e,h, had abrasion only, which can be explained as influencing the load of the thrust force mainly.

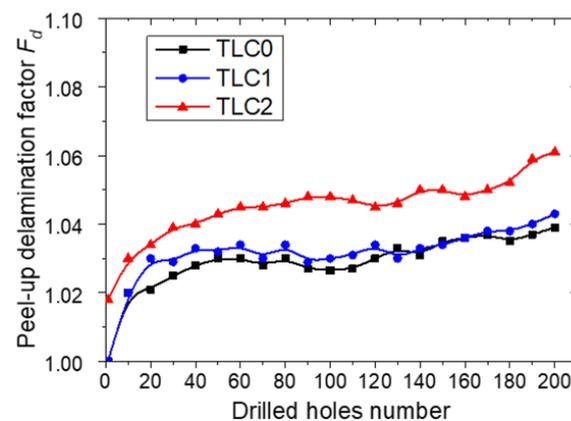
**Figure 14.** Variations of the delamination factor on the entry hole side as a function of the drilled holes number.

The maximal diameter of the damaged zone around each hole was measured using a digital microscope (VHX-1000SP, Keyence, Osaka, Japan). For both delamination cases, as shown in Figures 14 and 15, the curves of the delamination induced by the TLC0 and the TLC1 showed similar behaviors and correlated with the drill flank wear data. The tool wear evolution generated an increase in the torque and the thrust force, which led to the CFRP delamination appearance. Indeed, when the cutting forces value exceeded the interlaminar fracture toughness of the laminates, delamination occurred.

Meanwhile, the TLC2 induced some delamination since the first hole was drilled, as shown in Figures 14 and 15. Further, the peel-up and push-out delamination curves showed gradually increased trends. Such curves behaviors can be explained as the effect of the non-uniform globular formation of the diamond film along the drill cutting edges. These formations generated varied edge geometries with different cutting angles that may lead to an unstable cutting process through the vibration with changing of the cutting forces. Subsequently, abrasion led to a smoothing of the diamond film, and the delamination curves correlated with the corresponding flank wear curve.

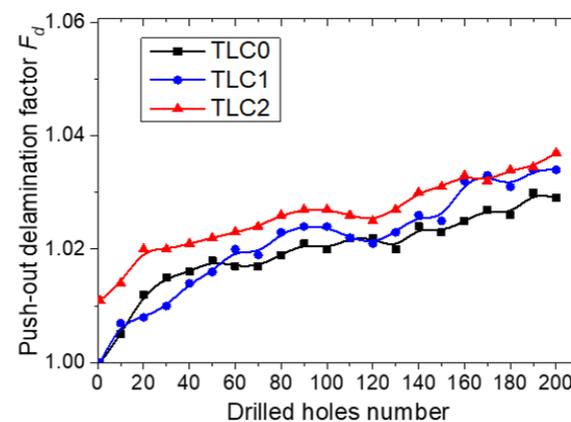
**Figure 15.** Variations of the delamination factor on the exit hole side as a function of the drilled holes number.

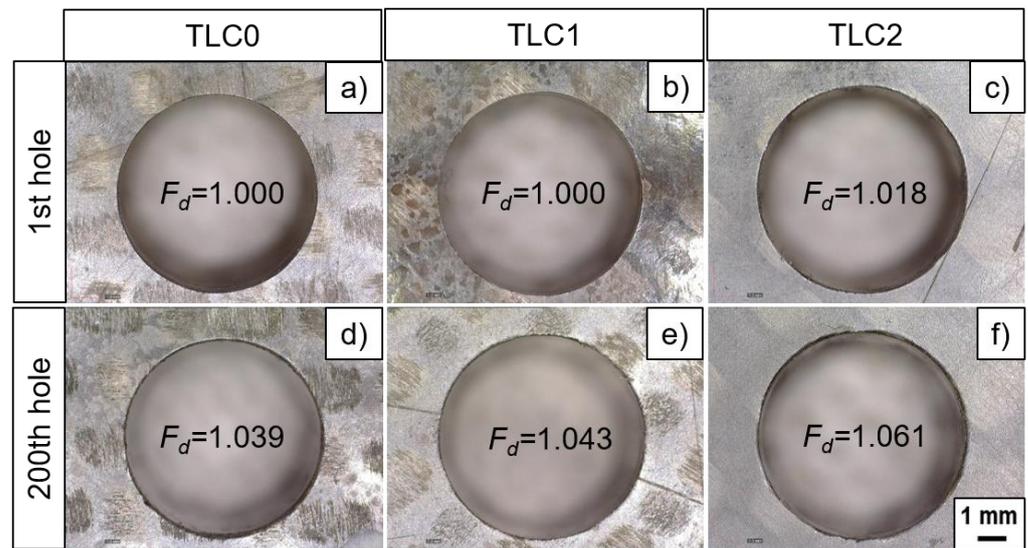
Figure 16. Images of the 1st and 200th CFRP hole entry sides made by the TLC0 (a,d), made by the TLC1 (b,e), and made by the TLC2 (c,f).

Figures 16 and 17 show images of holes entries and exits for the first and final holes drilled by the tested drills with the corresponding delamination factor values. The images presented the minor delamination of the last holes and the absence of cutting-induced breakout damages, such as burrs and splintering.

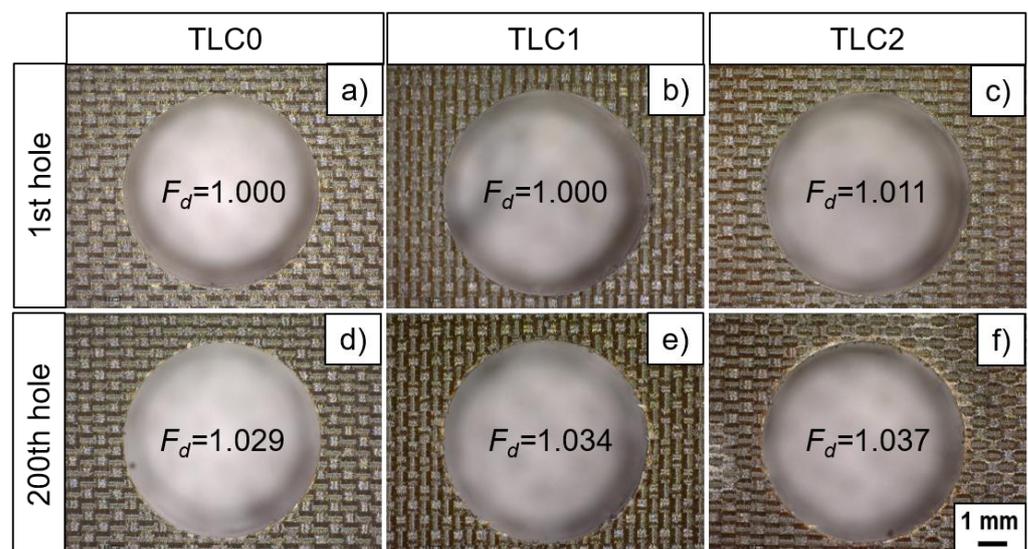
Figure 17. Images of 1st and 200th CFRP hole exit sides made by the TLC0 (a,d), made by the TLC1 (b,e), and made by the TLC2 (c,f).
